Renewal of old gold bars with new CAD/CAM bars; Feasibility with outdated implant systems

Joannis Katsoulis

Department of Reconstructive Dentistry and Gerodontology, University of Bern, Switzerland

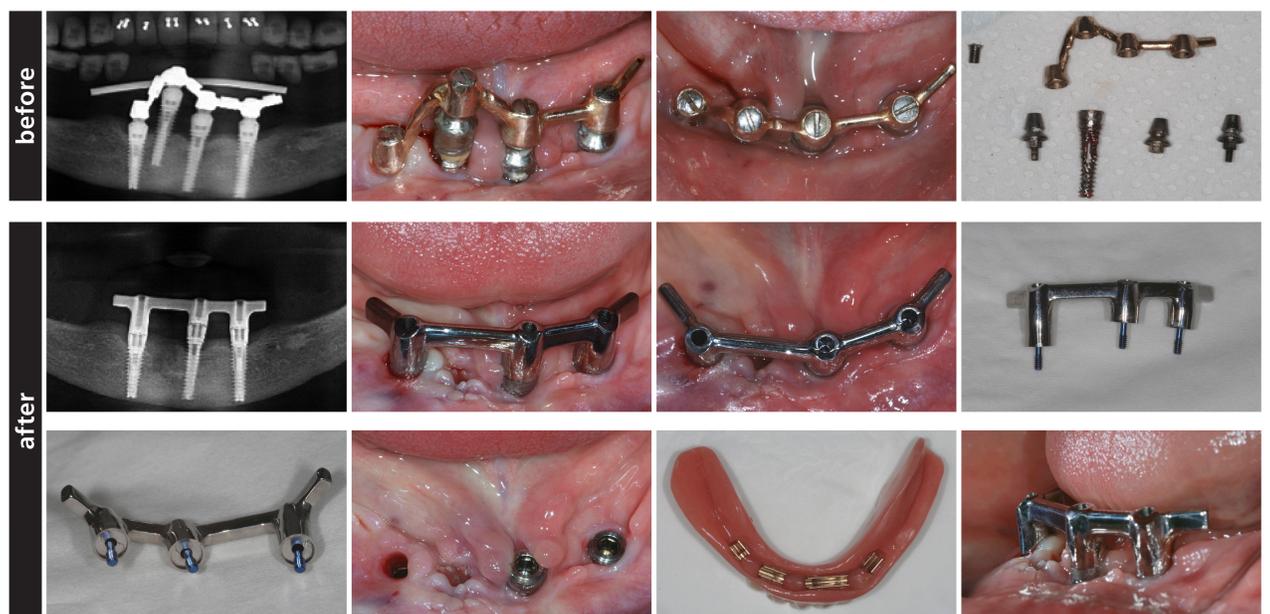
An elder patient with four HaTi implants placed 30 years ago recently suffered from pain at one implant and complained about the low IOD stability. One implant (42) had to be removed for biological (periimplantitis) and prosthodontic (vertical position) reasons. The old gold bar had very short interimplant segments with significant differences in level. The abutments and the gold bar were removed after a relining impression with the IOD (Impregum®) for fabrication of a new CAD/CAM titanium bar (allshape AG, Lengnau, Switzerland) that was screw retained directly on the implant (only one screw).

Digitization of the implant platform was done with a laboratory scanner (Imetric®) using the removed implant. Notice the straight and leveled segments (Dolder macro system, Cendres+Métaux SA, Biel/Bienne, Switzerland) between the 3 implants with bilateral extensions (Fig. 1a–k)

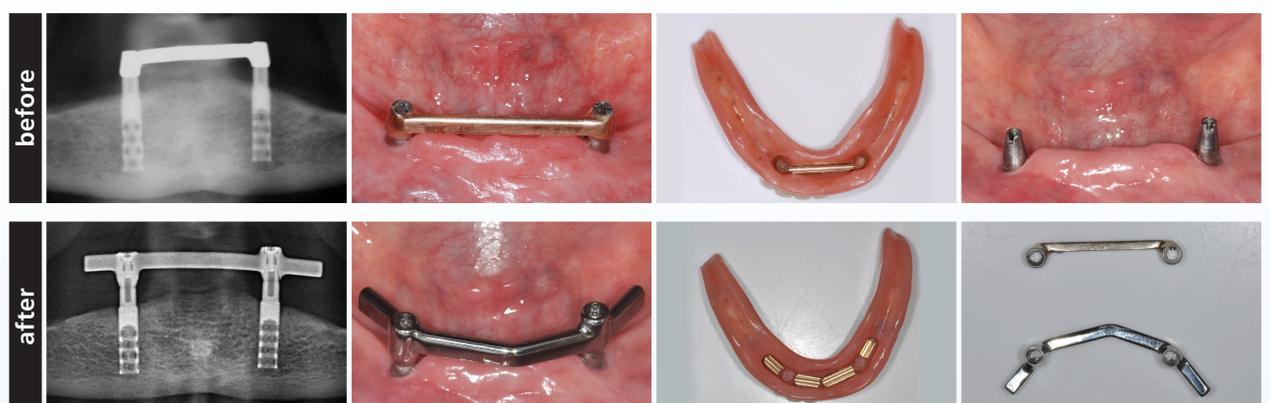
The bar attachment in the IOD of an 82-year old patient with Straumann Type-F implants (one piece) was fractured after >25 years in use. The therapy comprised the removal of the gold bar after a relining impression with the IOD (Impregum®). Digitization of the implant platform was done with a laboratory scanner (Imetric®) using the master cast from a second impression over the one-piece implants. A new rigid (Dolder macro design) CAD/CAM titanium bar with bilateral extensions (allshape AG, Lengnau, Switzerland) was screw retained directly on the implant with new occlusal screws (Fig. 2a–g).

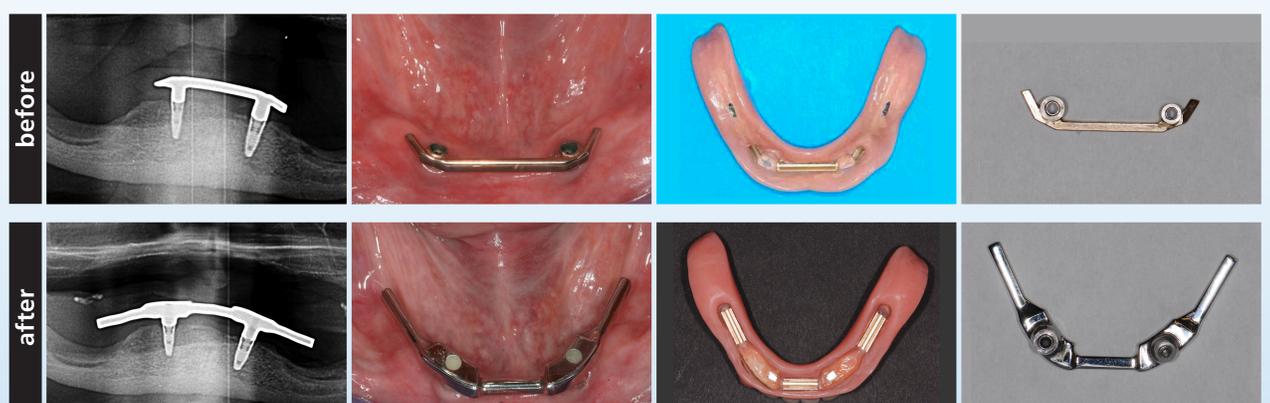
Chronic pain and inflammation of the lateral mandibular mucosa were caused by mechanical irritation from the IOD in a woman with an extreme atrophy of the posterior ridge. Notice that the canalis mandibulae and the foramen were located cranially (no cortical bone). Although there was an older gold bar supported by two Replace Select implants (Nobel Biocare) in the anterior area, the extensions were not sufficiently long to avoid tilting of the IOD.

As described above, a new CAD/CAM bar was fabricated with extremely long bilateral extensions of 25 mm length. CoCr was chosen for its higher mechanical stability. Furthermore, the bar around the implant access holes was designed more stable to resist the increased forces from the long cantilevers (Fig. 3a–f)
